Case examples  
of accidents  
(Forklift)

## 지게차 이송 중 파지묶음 사이에 끼임 Trapped between scrap paper bundles

# 지게차 이송 중 파지묶음 사이에 끼임

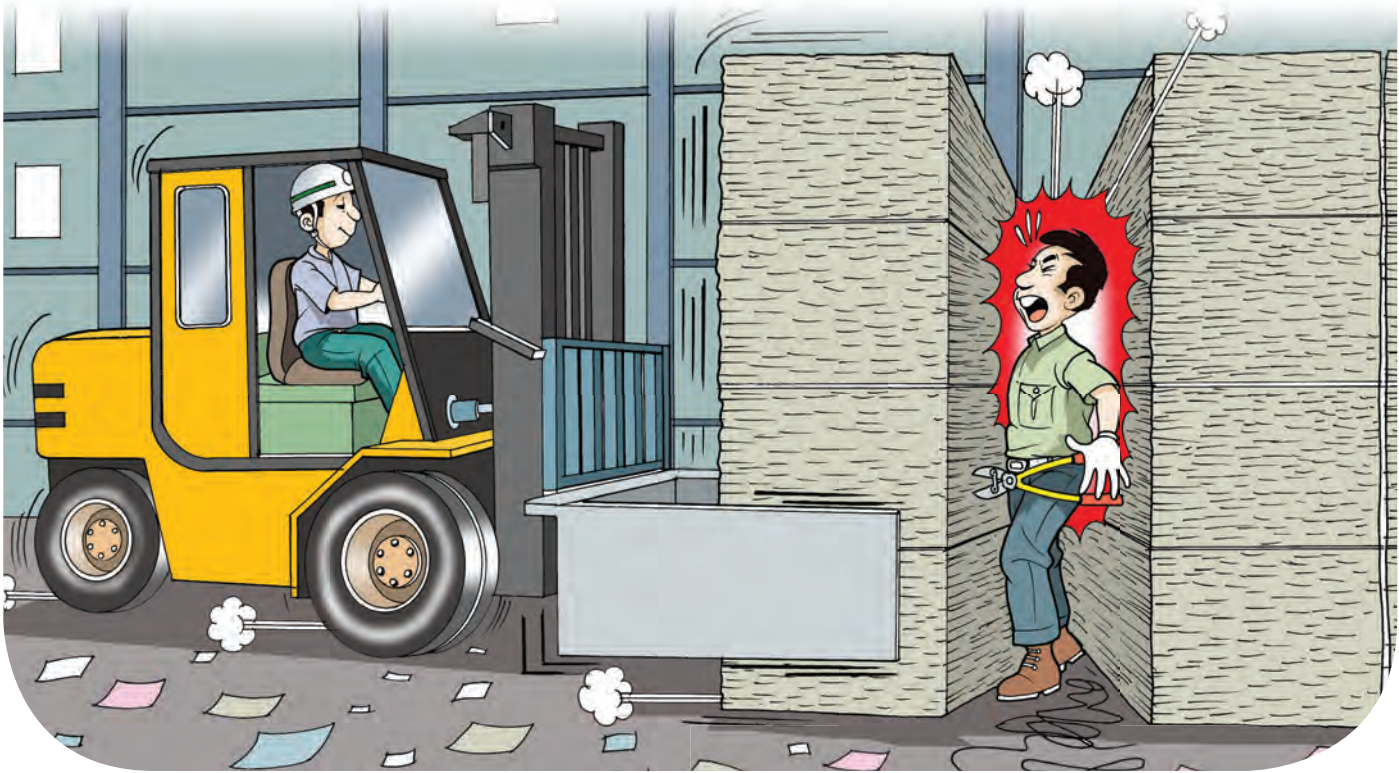
A 4.5-ton forklift, which was pushing scrap paper bundles against the wall while placing them onto conveyors at a paper manufacturer, failed to see a worker removing binding wires from the double-stacked scrap paper bundles, and the worker became trapped between the bundles.

- Failed to restrict access such as wire removal, etc. within the operating radius of the forklift
  - ※ Cube-shaped scrap paper bundles (base side 197 cm × 77 cm, height 100 cm, weight 700 kg)
- Performed work with view obstructed by double-stacked scrap paper bundles (approx. 2 m high)

- Restrict access to dangerous places that pose a risk of trapping and collision with cargo or forklifts within the operating radius of the forklift.
  - If the work requires access, position a supervisor or guiding personnel and set certain signals to perform work.
  - ※ Make sure all workers fully discuss their work paths and finishing times in advance.
- When loading cargo with a forklift, make sure the loaded cargo does not obstruct the view of the operator.

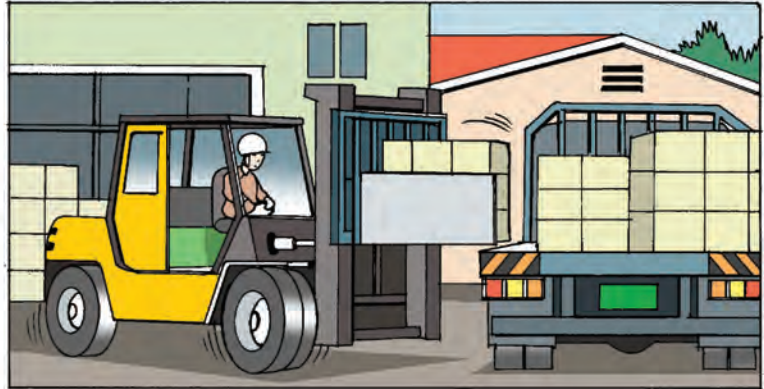
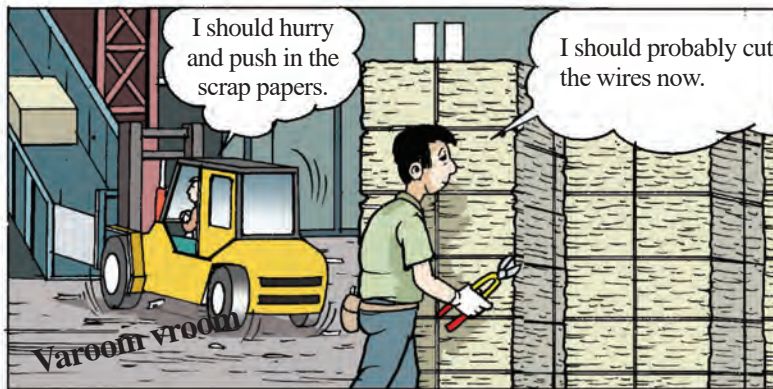
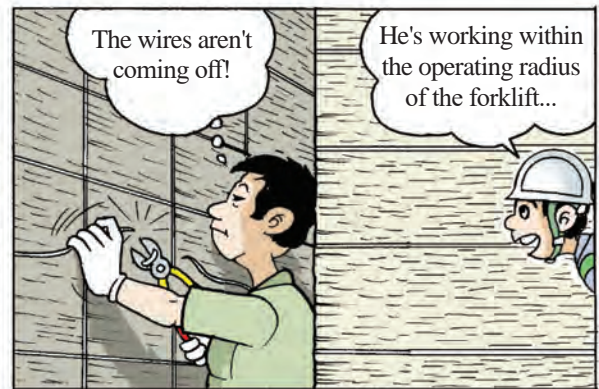
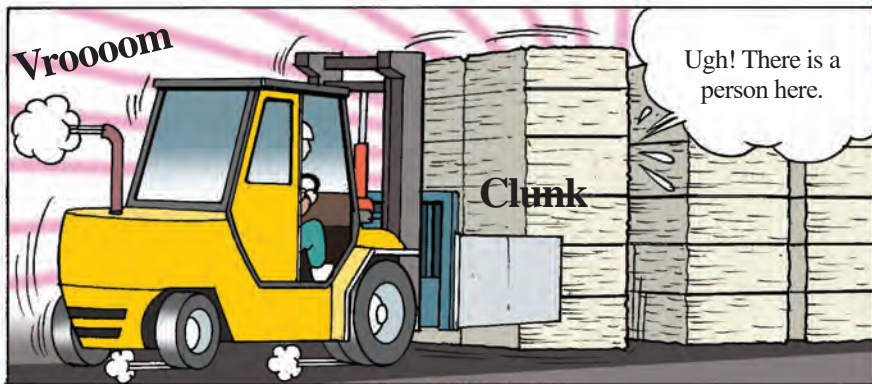
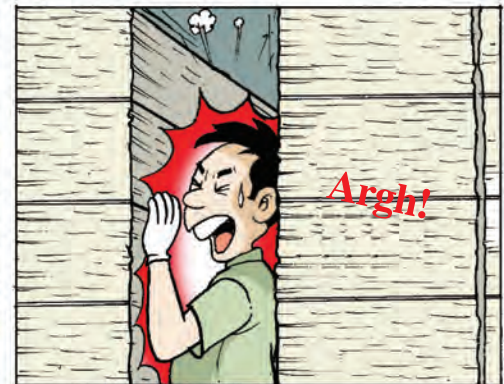
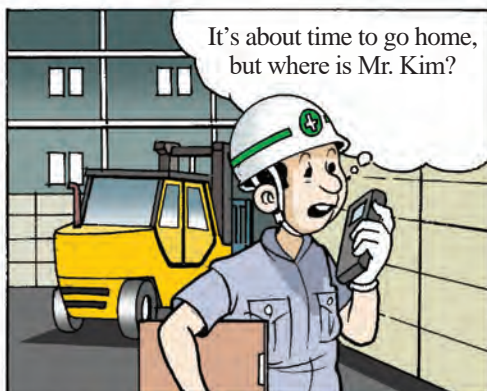
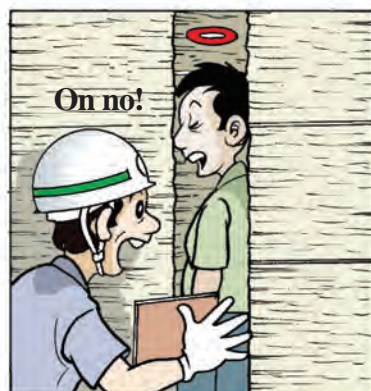
### Trapped between scrap paper bundles

A worker was crushed to death as the operator failed to notice the worker within the operating radius of the forklift.

Worker access must be restricted where there is any risk of contact with a forklift. Where access is unavoidable, make sure to position a supervisor or guiding staff and perform work according to their signals.

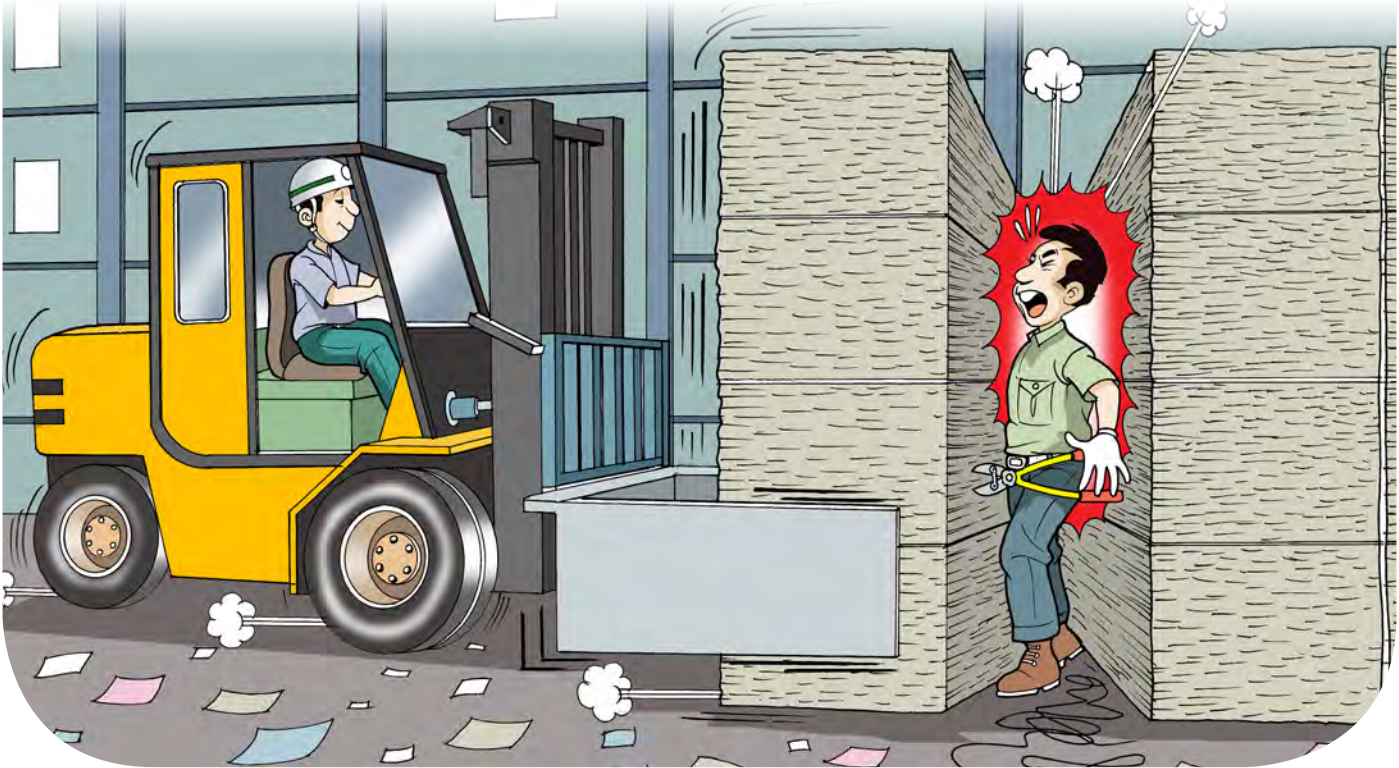
종이 생산업체에서 파지 컨베이어 투입작업에서 4.5톤 지게차로 파지묶음을 건물 벽쪽으로 밀던 중 2단 적재된 파지묶음 사이에서 밴딩용 철사를 제거하던 작업자를 발견하지 못한 상태에서 파지묶음 사이에 끼임

- 지게차 이송 등의 작업반경 내에서 철사 제거작업 등 출입 제한조치 미실시
  - ※ 직육면체 형태의 파지묶음(밀면 197cm×77cm, 높이100cm, 무게 약 700kg)
- 파지묶음 2단 적재(약 2m)로 지게차 운전자 시야가 확보되지 않은 상태에서 작업 실시

- 1 지게차 작업반경 내에서 화물이나 지게차 접촉 위험시 끼임, 부딪힘 우려가 있는 위험장소에 출입 제한
  - 작업 여건상 출입이 필요한 경우, 작업지휘자 또는 유도자를 배치 후 일정한 신호방법을 정하여 작업 실시
  - ※ 작업자 간 작업 경로, 종료시간 등에 대하여 사전 충분한 협의
- 2 지게차를 사용하여 화물을 적재하는 경우에는 지게차 운전자의 시야를 가리지 않도록 적재하여 작업 실시

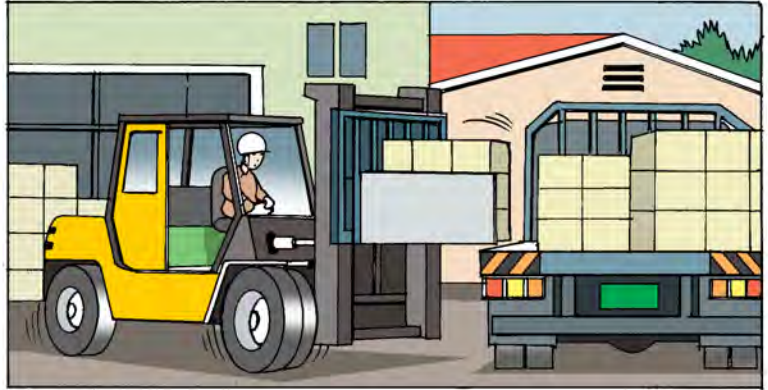
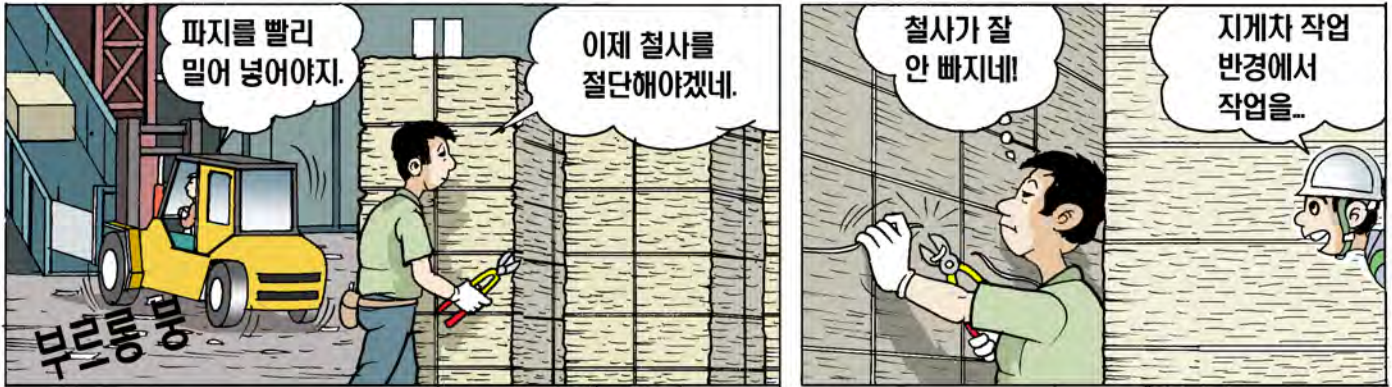
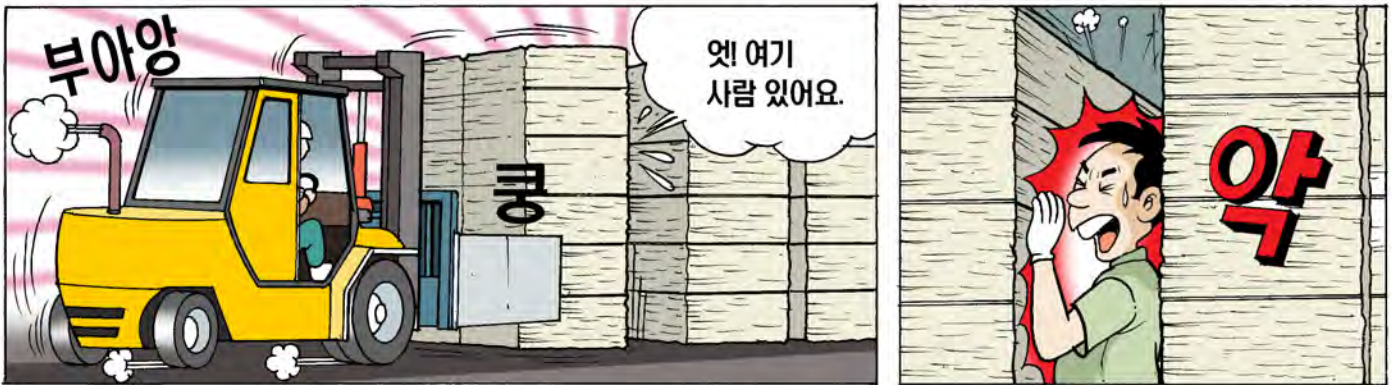
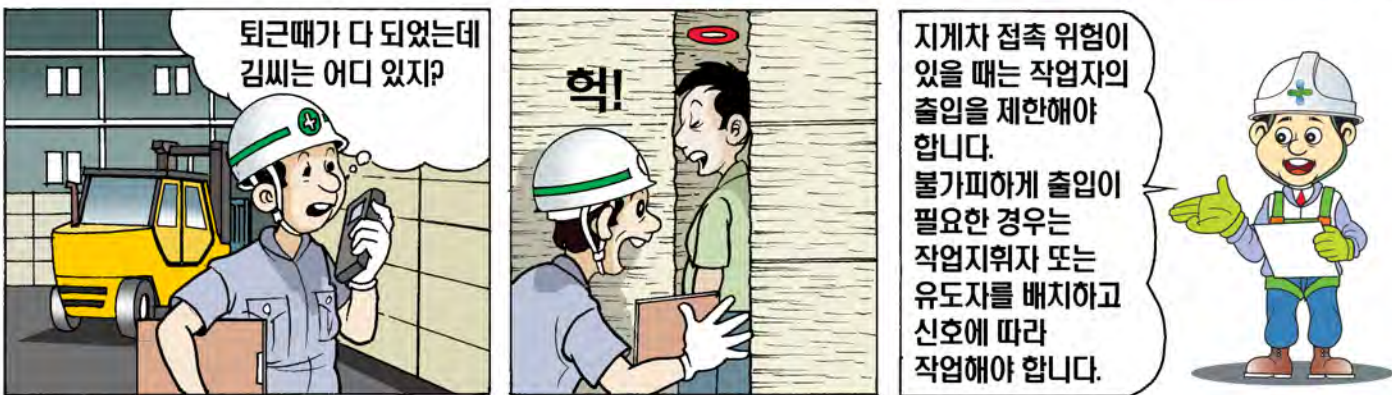
### 지게차 이송 중 파지묶음 사이에 끼임

지게차 작업반경 내  
운전자가 다른 작업자를  
발견하지 못해 1명이 끼여  
사망한 사고입니다.

## 지게차 작업, 유도자 신호에 따라 출입제한 하세요!
