Case examples
of accidents

(Forklift Forks)

Becoming trapped under unexpected dropping of
fork while repairing a forklift

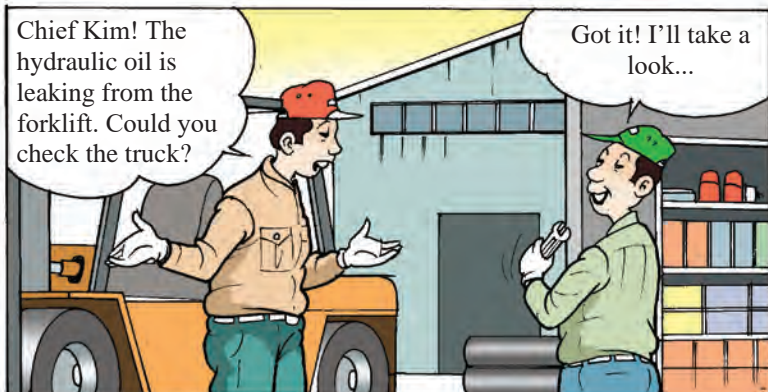
He is working underneath the fork without any safety pillars installed.

During repair or installation/disassembly of accessories for a transporting and loading vehicle, designate a supervisor and be sure to install safety pillars or safety blocks before performing work.

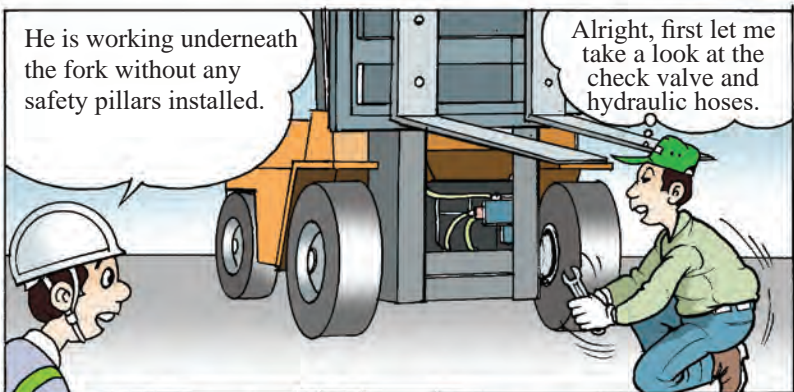
Alright, first let me take a look at the check valve and hydraulic hoses.
