Case examples  
of accidents  
(Forklift)

## 지게차 이송 중 파지묶음 사이에 끼임 Trapped between scrap paper bundles

# 지게차 이송 중 파지묶음 사이에 끼임

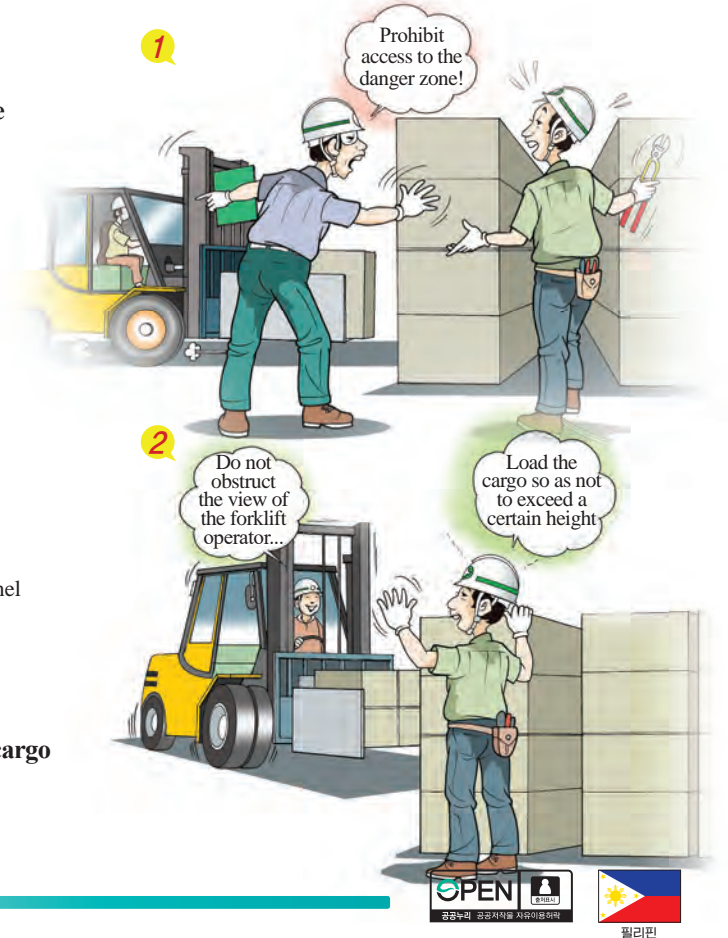
### Trapped between scrap paper bundles

A 4.5-ton forklift, which was pushing scrap paper bundles against the wall while placing them onto conveyors at a paper manufacturer, failed to see a worker removing binding wires from the double-stacked scrap paper bundles, and the worker became trapped between the bundles.

- Failed to restrict access such as wire removal, etc. within the operating radius of the forklift
  - ※ Cube-shaped scrap paper bundles (base side 197 cm × 77 cm, height 100 cm, weight 700 kg)
- Performed work with view obstructed by double-stacked scrap paper bundles (approx. 2 m high)

A worker was crushed to death as the operator failed to notice the worker within the operating radius of the forklift.

- Restrict access to dangerous places that pose a risk of trapping and collision with cargo or forklifts within the operating radius of the forklift.
  - If the work requires access, position a supervisor or guiding personnel and set certain signals to perform work.
  - ※ Make sure all workers fully discuss their work paths and finishing times in advance.
- When loading cargo with a forklift, make sure the loaded cargo does not obstruct the view of the operator.

Worker access must be restricted where there is any risk of contact with a forklift. Where access is unavoidable, make sure to position a supervisor or guiding staff and perform work according to their signals.
